EL PASO BUILDING

Building Location: 1001 Louisiana Street Houston, Texas

Date of Site Visit: 9/19-20/06

Field Notes, Background & General Observations

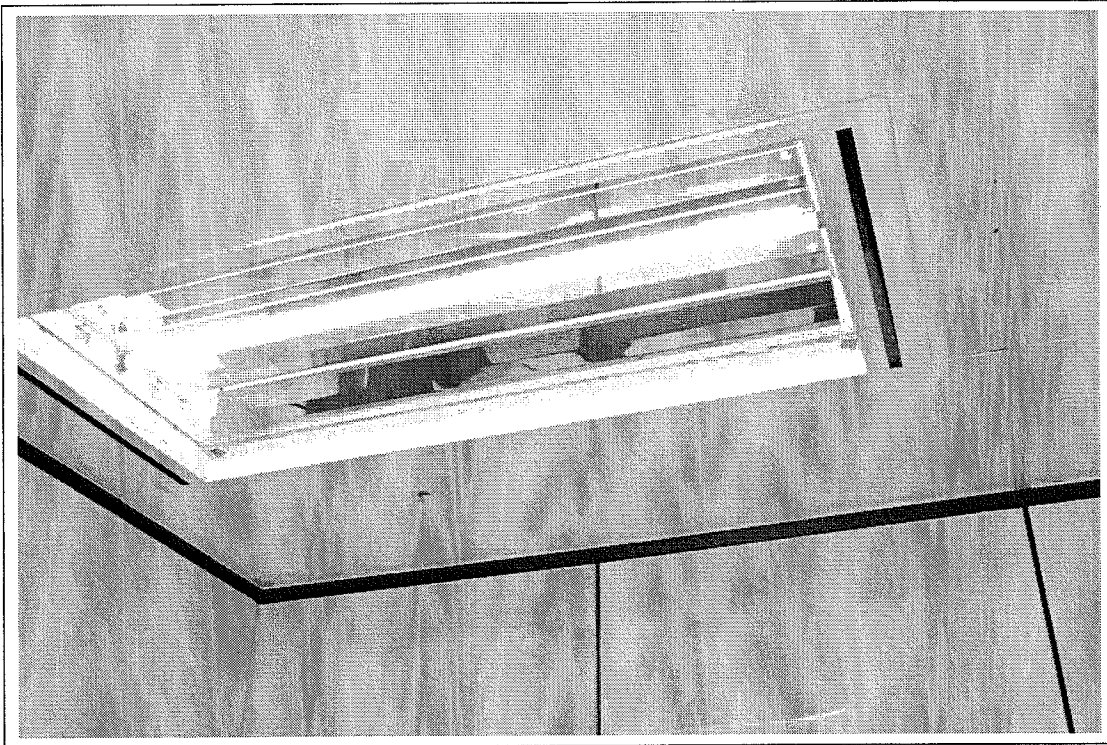
Photo 60. 10th floor, room W1011B - General view of fluorescent light fixture/ceiling grid system

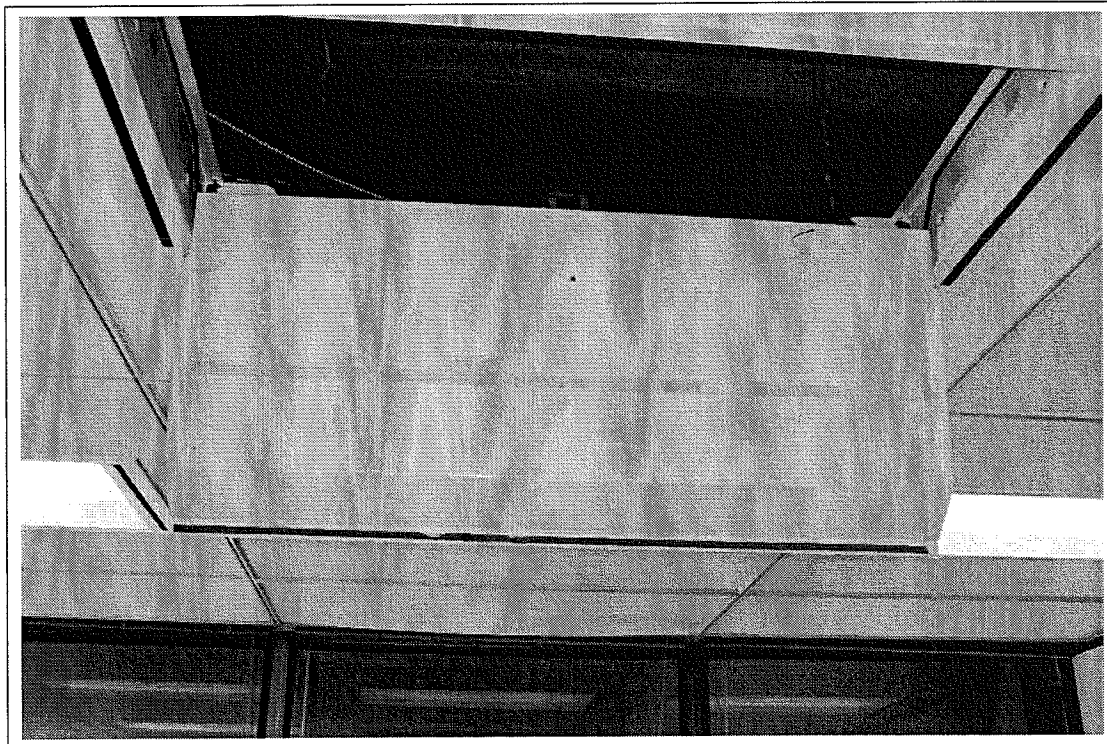
Photo 61. 19th floor, room SE1952B - View of fine dust layer on back of fluorescent light fixture
